SILVER LAKE RESERVOIR
RICHMOND COUNTY, NEW YORK
INVENTORY NO. 60

PHASE I INSPECTION REPORT
NATIONAL DAM SAFETY PROGRAM

NEW YORK DISTRICT CORPS OF ENGINEERS

SEPTEMBER 1978

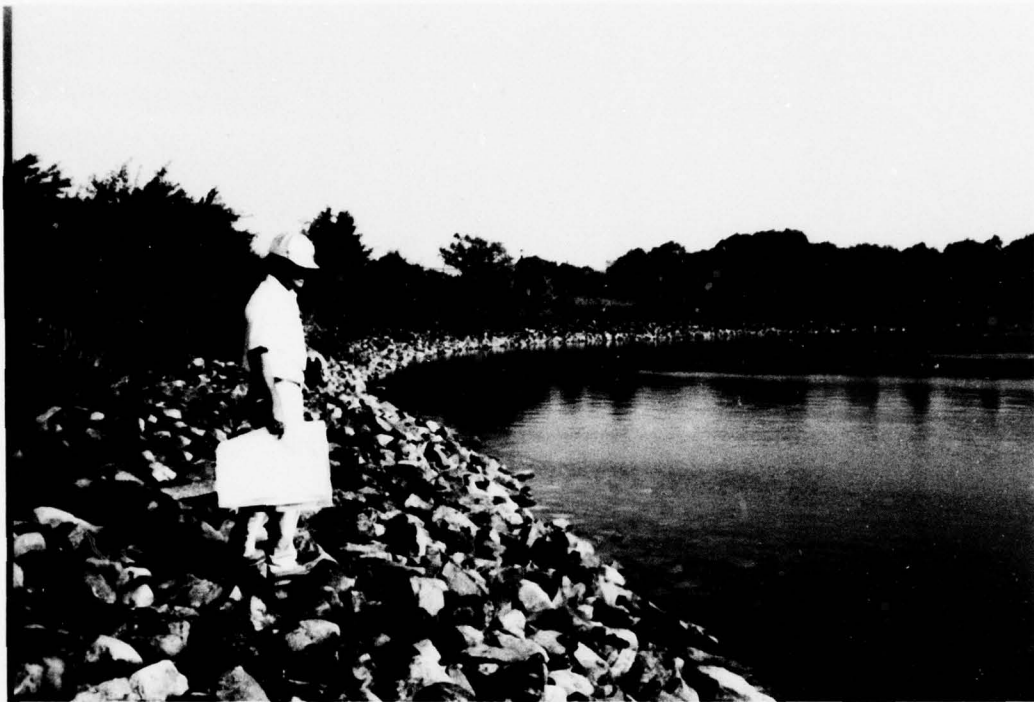
UPSTREAM SLOPE OF NORTH DIKE,
LOOKING NORTH

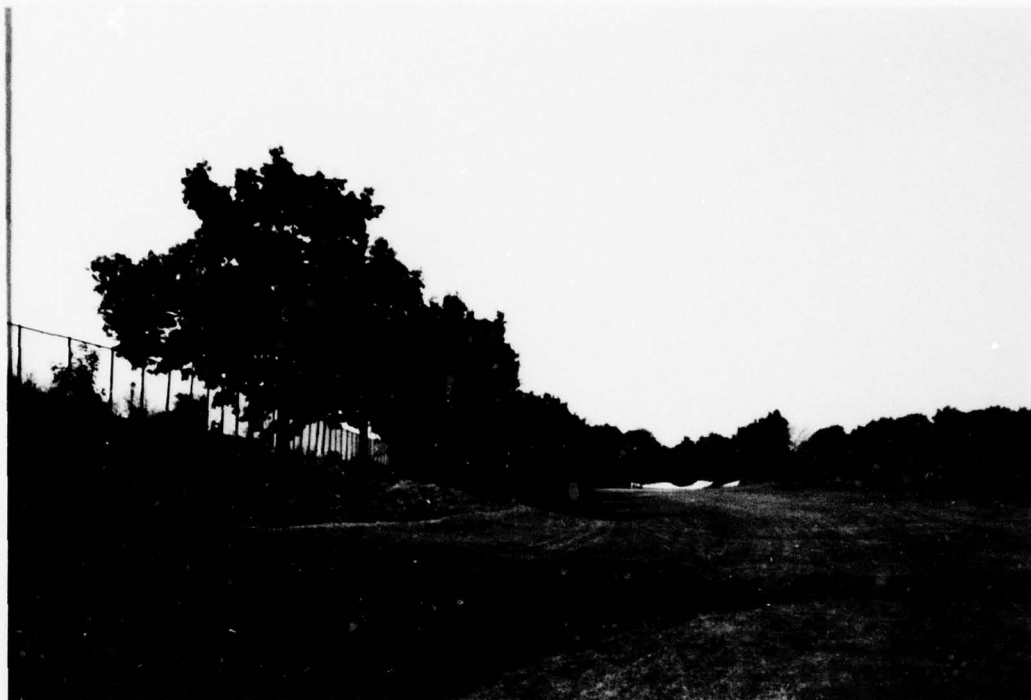
DOWNSTREAM SLOPE OF WEST DIKE, LOOKING SOUTH

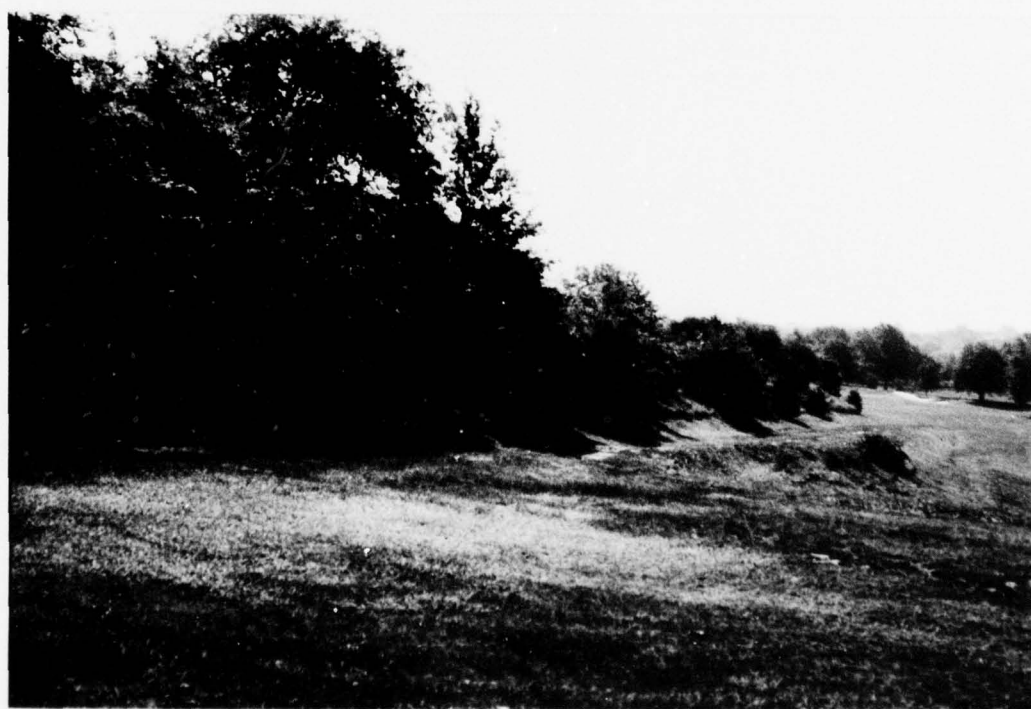
DOWNSTREAM SLOPE OF SOUTH DIKE, LOOKING EAST.
CREST IS NOT VISIBLE; FLAT AREA IS BERM AT EL 218±

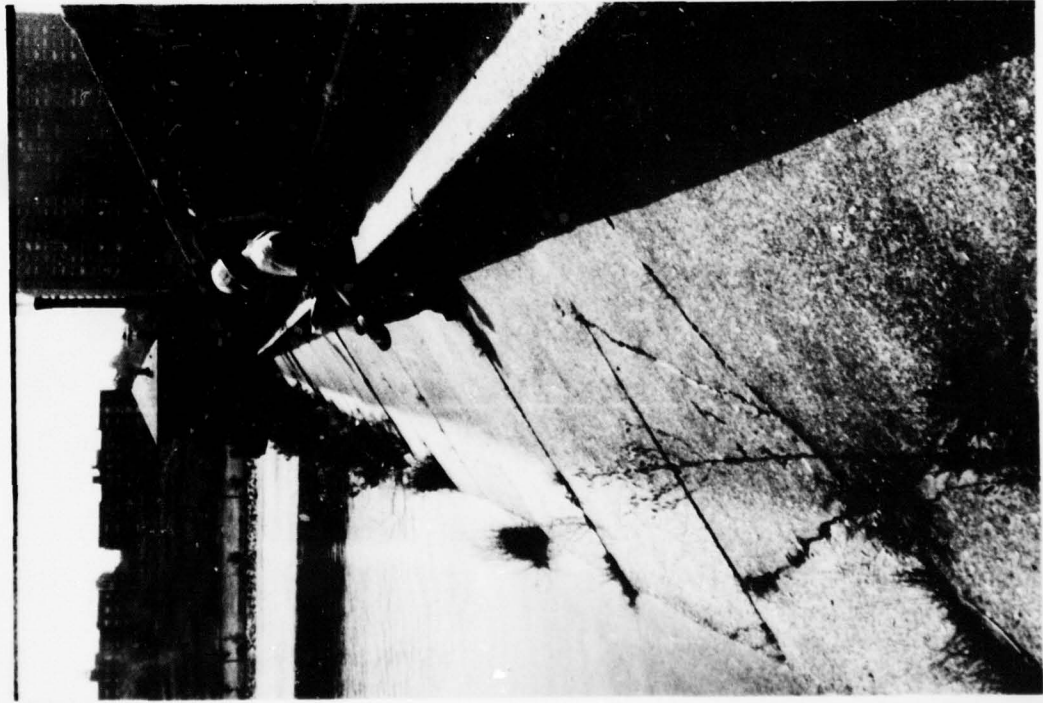
NORTHWEST FACE OF MIDDLE DIKE, LOOKING
EAST AT NORTH GATE HOUSE FROM WEST END OF DIKE

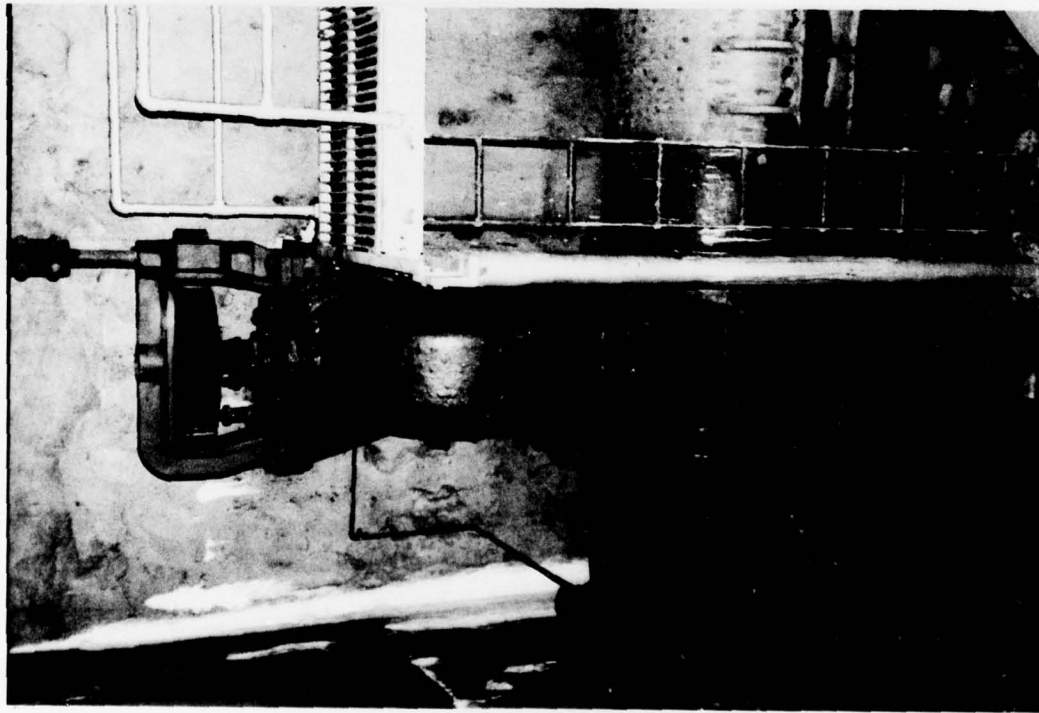
SOUTH BLOW-OFF GATE VALVE,
LOCATED IN VALVE CHAMBER

- b. Repair and maintain, as required to operate manually, the low level outlets (the 36 inch blow-off gate valves and the 30" x 92" sluice gates).
- c. Maintain in a clean and operable condition the waste weirs, the weir chambers and overflow wells.

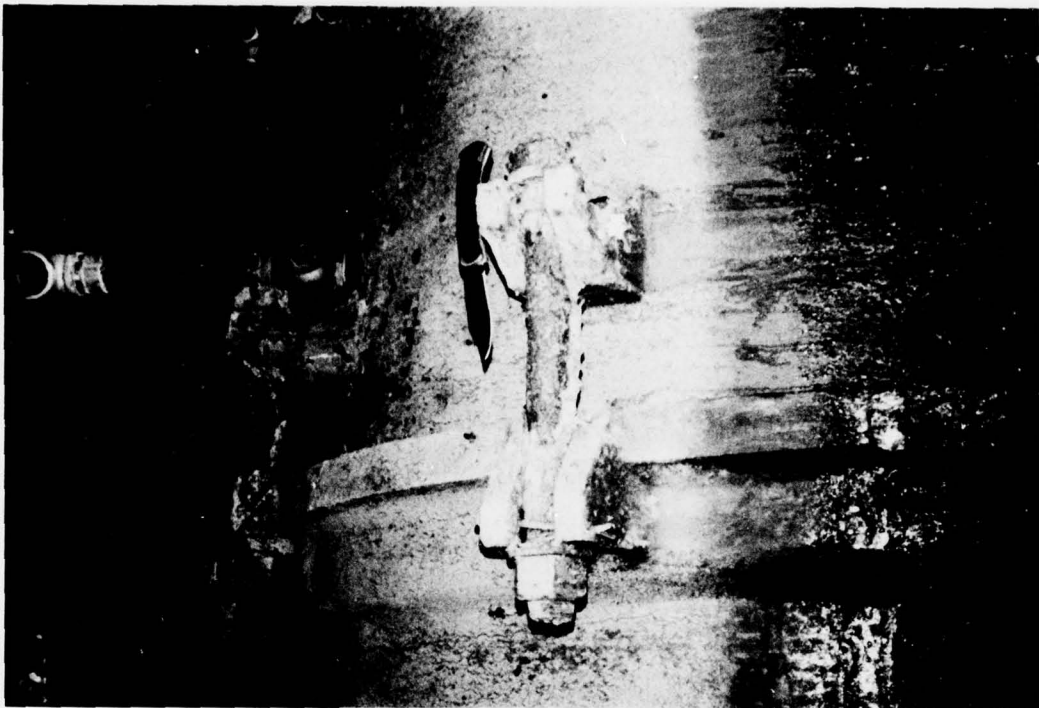
It was not determined whether the gate operating motor or drive train were operational. In general, the gate operating stands appeared to be in good condition to be operated manually. The gates themselves appeared to be in operable and in relatively good condition, even though they had been neither operated nor maintained since 1971. The condition of the exposed conduits appeared to be good. In general, the tie rods connecting gates to conduits were severely corroded.

The debris in the weir chamber should be removed to prevent blockage of the overflow well. The corrosion of the tie rods is considered to be an undesirable condition.

CORRODED TIE RODS (TYPICAL) CON-
NECTING CONDUIT TO 48 INCH CAST
IRON MANIFOLD

- d. Replace corroded tie rods in the valve chamber.
- e. Heavy brush, shrubs and young saplings should be removed from all locations on the embankments. Large conifers, but not deciduous hardwoods, should be removed. The remaining trees should be inventoried and their condition monitored. If a tree dies, the area around the tree should be closely monitored for seepage.
